**SUBMILLIMETER ARRAY PROJECT
TECHNICAL MEMO 145**

TITLE: TESTING OF NYTEX TUBES FROM ANTENNA 1 AFTER 3 YEARS OF SERVICE AT SIMPSON, GUMPERTZ & HEGER, INC.

REPORT ON SMA TESTING, JOSHUA B. KIVELA

SUBJECT: Strength of Carbon Fiber Tube Assemblies

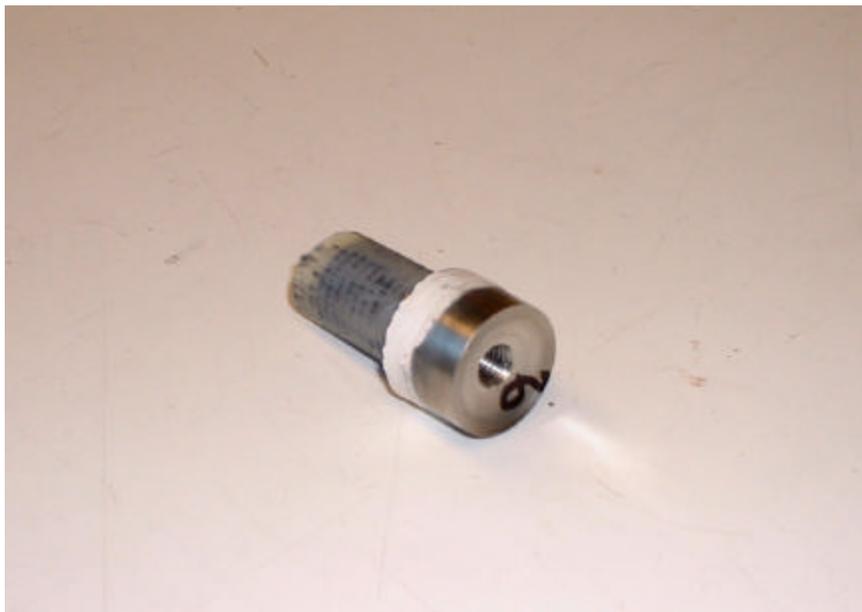
Photo 4

The 19.20 mm and 23.30 mm I.D. carbon fiber tubes appear to have grooves on their inner surfaces. This is noticeable when looking at the stainless steel end fittings and the inside surface of the carbon fiber tubes (Photos 4, 5, 7). Most of the specimens failed adhesively between the epoxy adhesive and the carbon fiber tubes. Carbon fibers are visible on some of the stainless steel end fittings.

Stainless steel end fitting (19.20 mm OD.) with carbon rings and fibers.

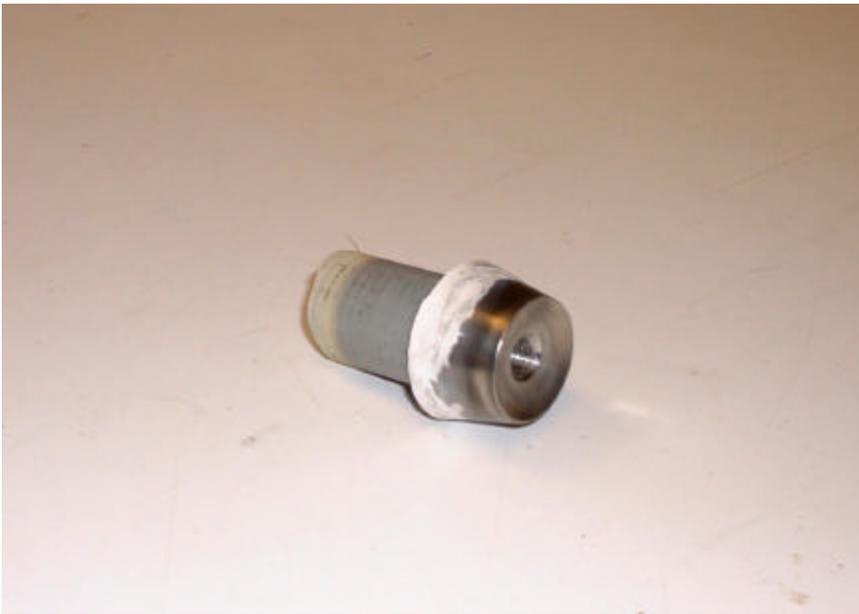
Photo 5

Stainless steel end fitting (23.30 mm O.D.) with carbon rings.

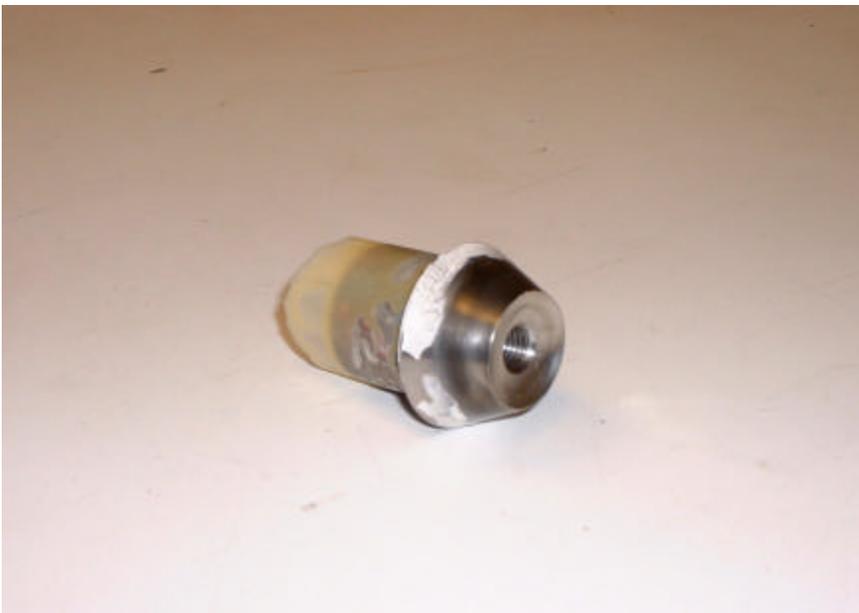
Photo 6

The 31.50 mm I.D carbon fiber tubes do not appear to have grooves on their inner surfaces (Photos 6, 8). All of the 31.50-mm I.D specimens failed adhesively at the bond line between the carbon fiber tubes and the adhesive.

The -19 tubes are a real concern. We had a 50 % failure rate with them. The three tested articles and one that failed when tapping, show different processing of the bond line. The tube ends have not been grooved or even roughened. This was one of the design recommendations mentioned earlier. It is apparent in the small tubes tested that it did significantly increase the bond strength and should be employed throughout the tube family. It is not clear if these -19 tubes were processed before the design changes were implemented. This needs to be investigated.

Stainless steel end fitting (31.5 mm O.D.) with no carbon rings.

1. A continuing test program for crack tubes should be instituted. This will provide additional tube strength/environmental exposure statistics while monitoring tube assemblies from various manufacturing lots.
2. We must develop a method of sealing the tube cracks to prevent possible water/ice cycles, which could further damage the tubes thereby altering their strength.
3. We must investigate which tubes were processed without the tube ends being grooved or roughened.
4. More –19 tubes and other tubes of large inside diameters should be tested. This will provide additional data to explore possible strength issues.

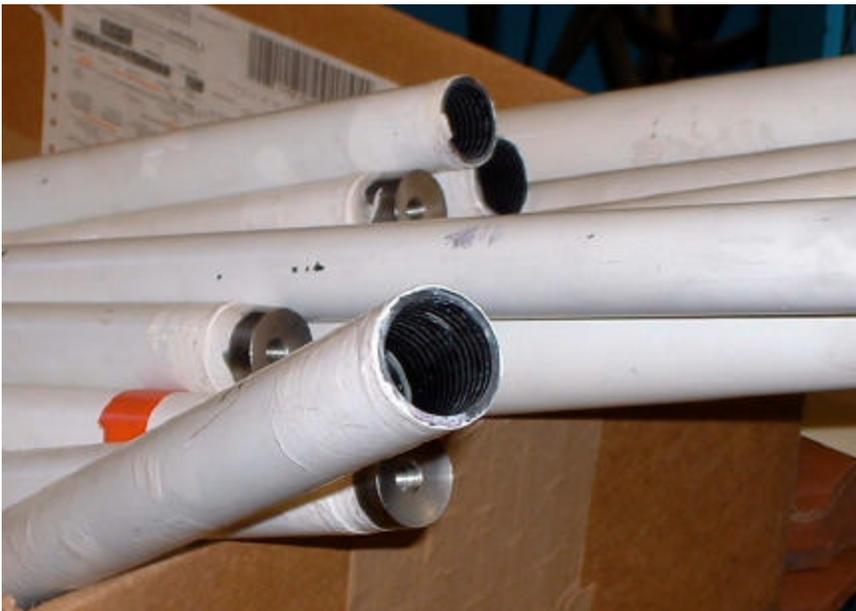
Photo 7

Carbon fiber tube (23.3 mm I.D.) with grooved rings.

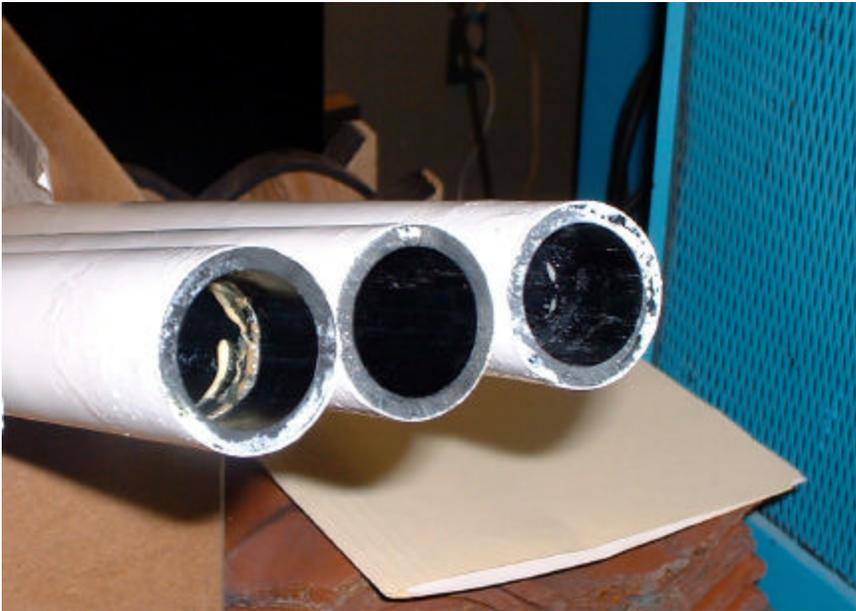
Photo 8

Carbon fiber tube (31.5 mm I.D.) with no grooves.
