ADC service trip of June 2007

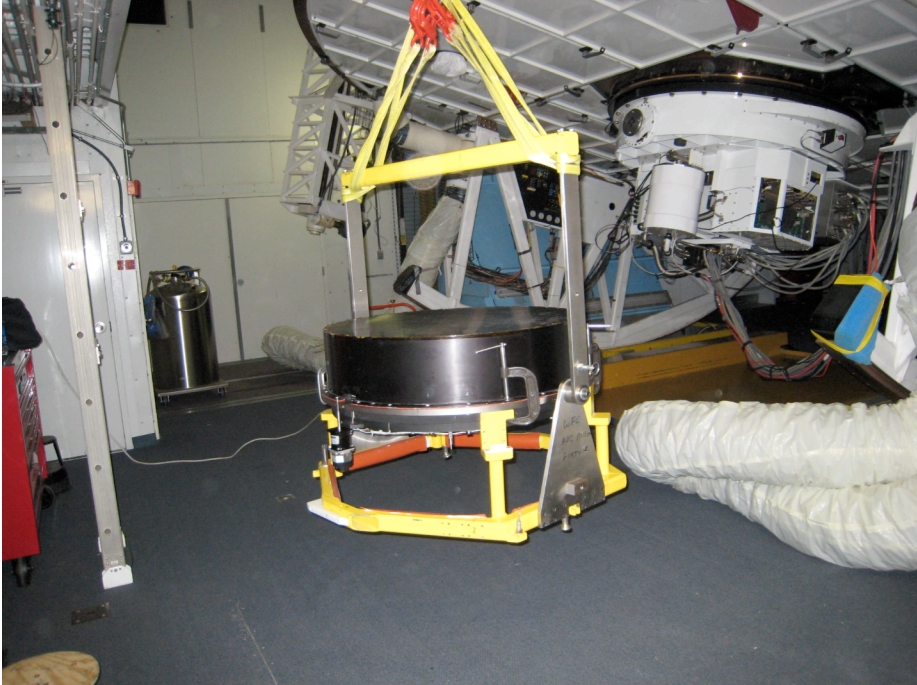
pictures of procedure
Crane picking up unit with ADC lifting fixture.

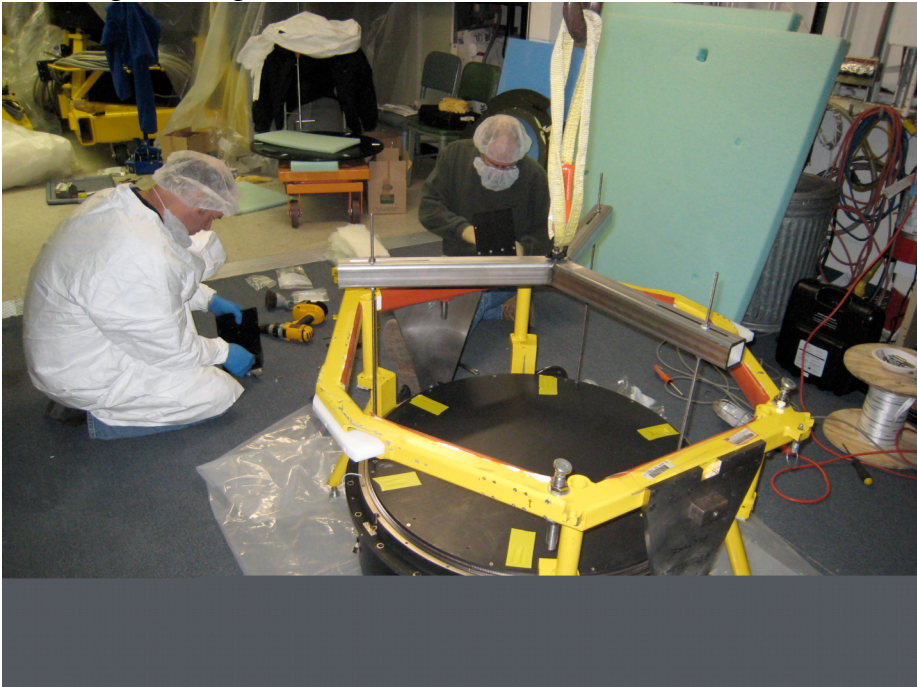
Bob Fata and Kevin Bennett preparing trunions for the prism lifting fixture prior to extracting the east prism.

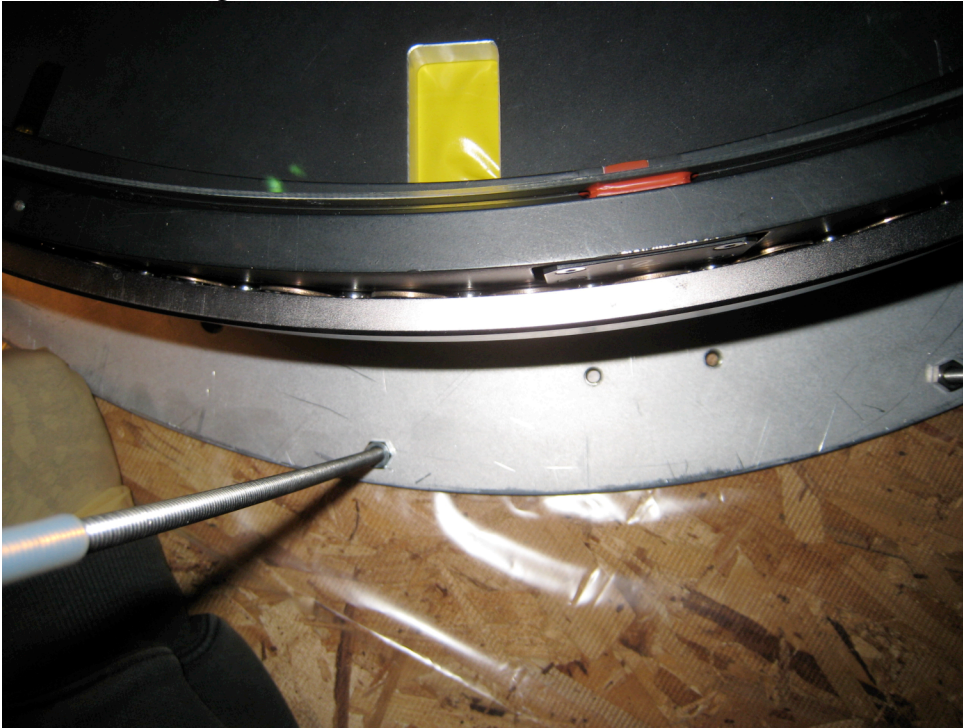
View into bearing race and balls with brass washers on alternate ones.

No obvious problems were seen with the ball bearings or the gear, though visibility was not great. A small amount of Krytox LVP grease was applied to every other ball in the bearing and then the bearing was rotated. It turned much better. The required force was lower and uniform. The exposed optical surface was cleaned. A small brush was used to pick up the larger contaminants on the glass and then the surface was swept with a stream of UHP nitrogen gas. A bird cage structure was put over the prism and covered with the Wide Field Corrector plastic while we worked on the second prism.

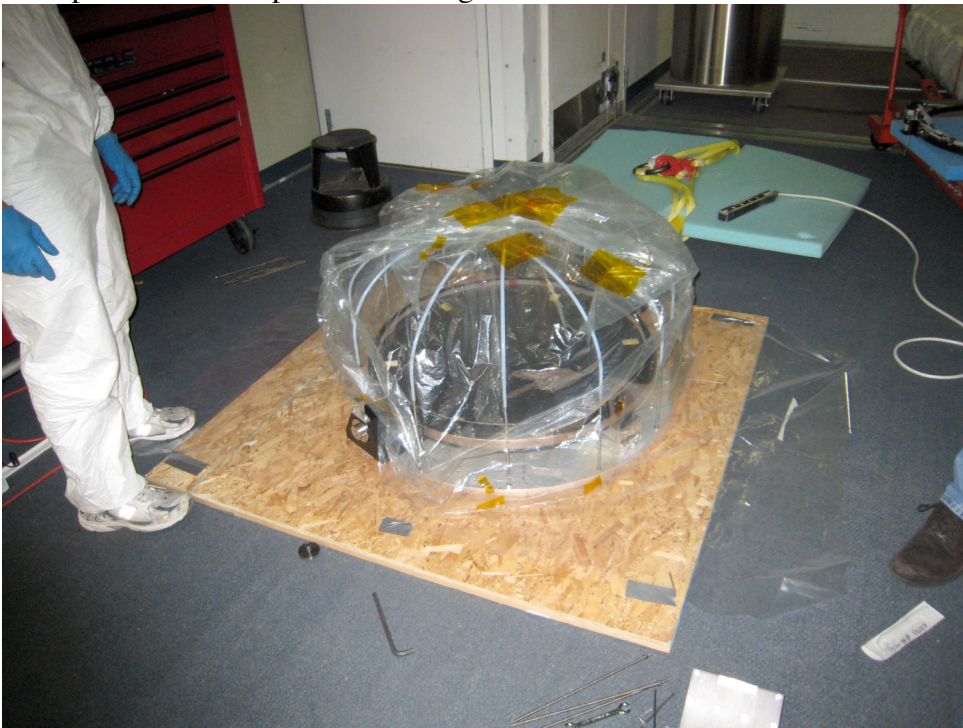
East prism covered up in its bird cage.

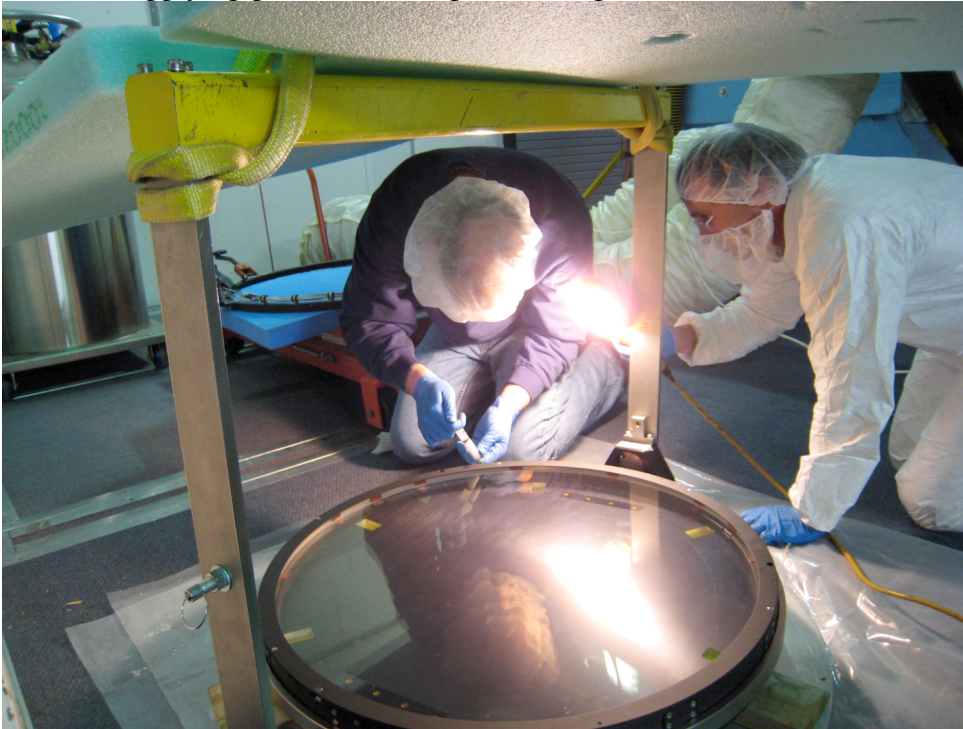
Bob Fata applying grease to bearings the west prism under foam umbrella.

The spacer ring between the bearings was removed and the safety screw was backed out prior to lifting out the second prism. We attached the trunions from the ADC since we did not have a full set and set the second prism down on plastic spread out on the floor. The second prism was also flipped over, the bearing greased, and the optical surface cleaned.

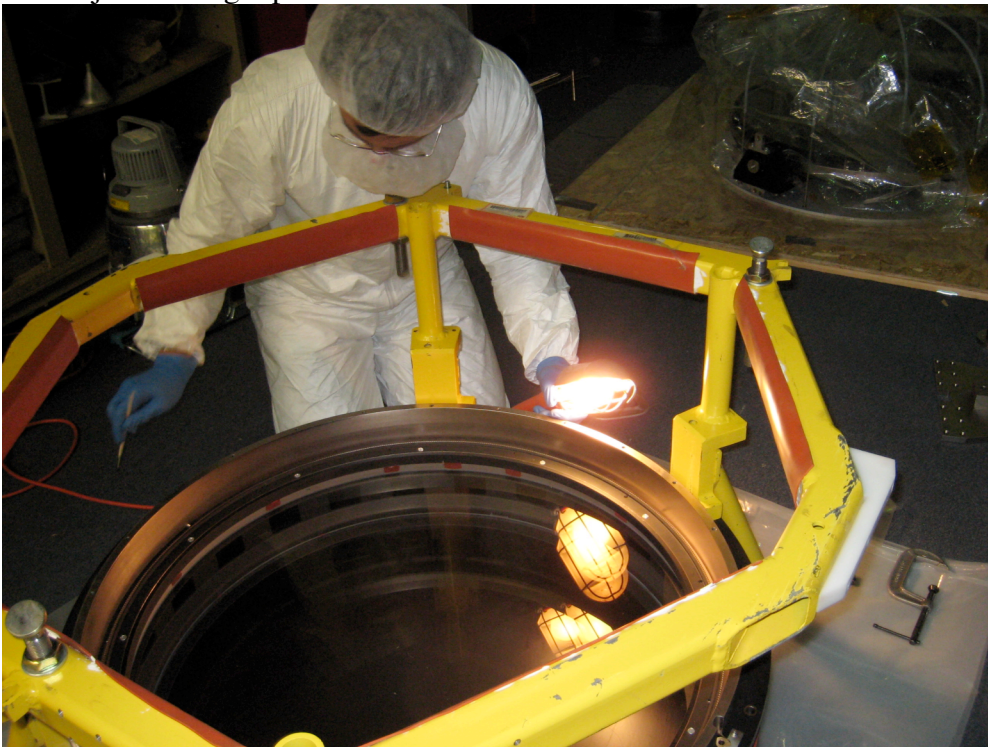
Joe Zajac cleaning optical surface with small brush.
