# Memo 120 Part II SMA No. 41700490000

Comm. 96755 - Carbon Fiber Tube Assemblies for the SMA Antennas

Subject: Short term and cyclic testing of Type -25 tube specimens

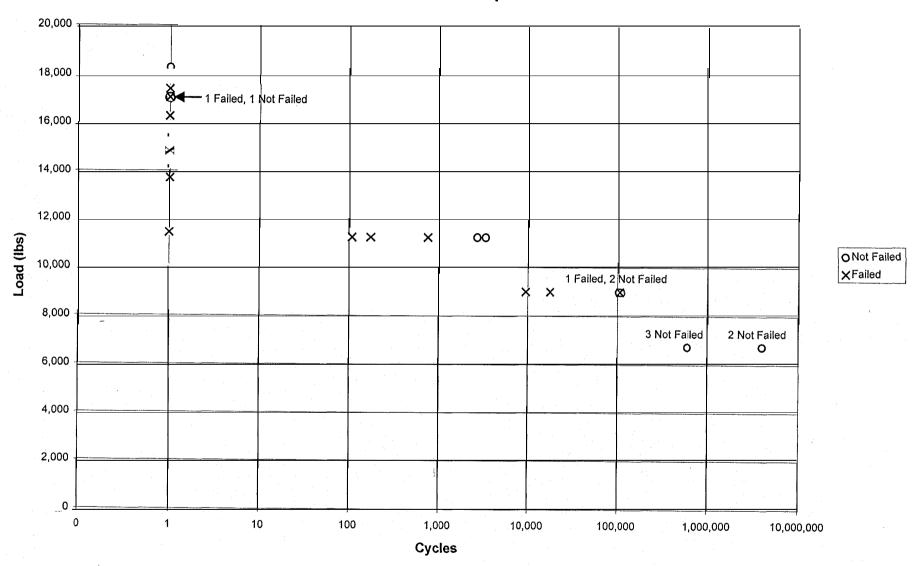
F<sup>igu</sup>re 1. S-n plot

The S-n plot (load vs cycles) of the cyclic loading results is shown in Figure 1, a semi-log plot. The plot shows the number of cycles each specimen was subjected to, and whether or not it failed.

Based on the results of the above 8 tests, the load level of the first cyclic tests were set at 50 kN (11,240 lbs), the highest level at which one would not expect failures at the first cycle. The other two load levels were set at 40 kN (8,992 lb), and 30 kN (6,744 lb). The results of the

In view of the scatter in the results at the 50 kN and 40 kN tests, and after the specimens at 30 kN had sustained a large number of cycles without any failures, the cyclic testing was stopped, and the specimens which had survived the cyclic loading were subjected to short term axial tests to determine if the cyclic loading had reduced their strength. The results of those tests are shown in Table 3, and photographs show the failed surfaces.

Similarly, in the specimens that failed under cyclic testing the failures were in the adhesion to the metal. The results for short term axial tests for the specimens that survived the cyclic loading, Table 3, compared to those for specimens not subjected to cyclic loading, Table 1, show no reduction in strength. The mean is the same and the standard deviation reduced. One, specimen 25-34, failed at a low load, 51.94 kN (11,677 lb) with a split tube. Of the 8 remaining specimens the lowest failure load was 65.79 kN (14,790 lb), and 4 specimens failed by stud break. Thus the cyclic loading eliminated the specimens with weak adhesion, but did not cause a noticeable reduction of the strength of the other specimens. This is similar to cases in which fatigue failure is initiated by crack growth; the crack will grow only if it is larger than some initial size.

Since none of the 5 specimens tested at the cyclic load of 30 kN failed by adhesion to metal in the subsequent short term test, there is no data as to the number of cycles a specimen of Category A would sustain at the 30 kN level.
